A6 to Manchester Airport Relief Road

Tree Survey
1007/6.15.2/185

October 2013

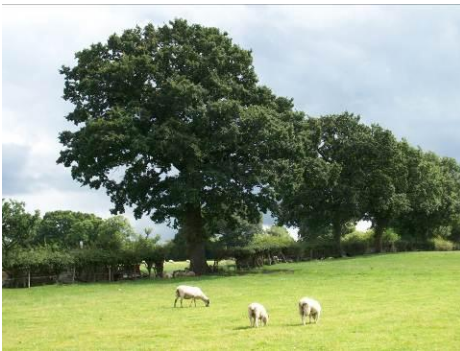
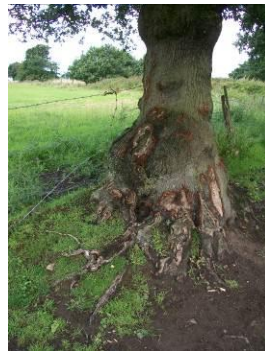
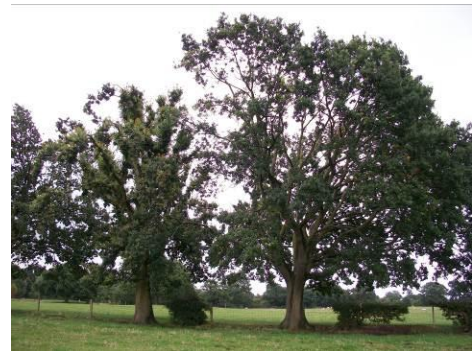
English Oak (*Quercus robur*) was well represented within the wider agricultural landscape including former agricultural areas which are now used for other purposes. A majority of Oak trees appeared to be of similar age range which would imply a significant phase of planting in the late 19th Century and early 20th Century, (Photo 1). A few isolated specimens appeared to predate this but were generally less common within the survey area. A number of trees were affected by current agricultural practices including rootzone compaction from livestock access, bark damage, nitrification of soils and mechanical damage from agricultural machinery or hedgerow flailing, (Photo 2). Many Oak trees appeared to have thinning canopies which may be symptomatic of these processes, (Photo 3). The traditional field Oaks remain a characteristic component of the survey.

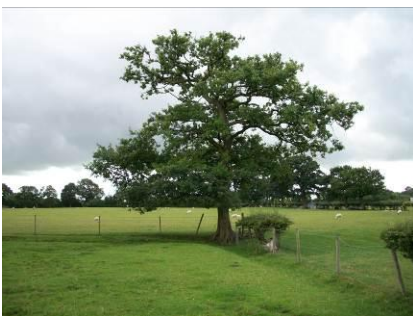
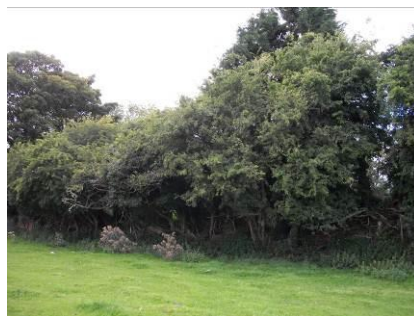
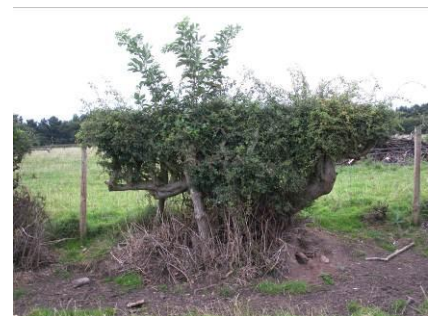
The survey area included numerous examples of lapsed hedgerow management which included sections of out-grown hedgerow, gappy or otherwise intermittent sections of hedgerow vegetation or ghost hedgerows which have been lost and where the only evidence comprises redundant ditch courses or field trees, (Photo 4). Again, many sections were impacted by current agricultural practices including lapsed cutting regimes, rootzone compaction from livestock access, bark damage, nitrification of soils and mechanical damage from agricultural machinery or hedgerow flailing, (Photo 5). Despite this, some sections of historic hedgerow laying, (Photo 6) were visible and the occasional out-grown Hazel coppice stool.

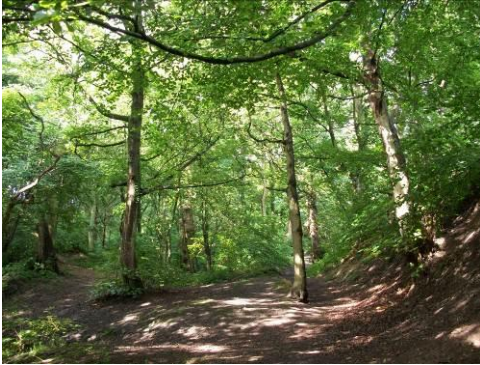
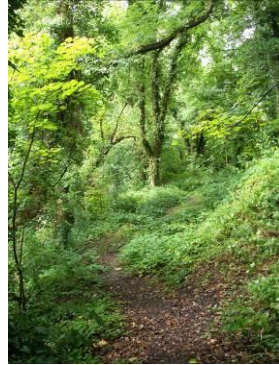
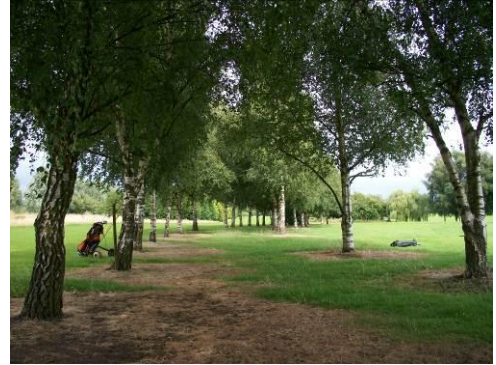
Part of the woodland area included within the G76 was noted as being of Ancient Woodland status. Within England and Wales, this is stated as being areas that have been continuously wooded since 1600 and may contain rare or unusual species and/or habitats, (Photos 7 and 8). The northern boundary of the group was marked by a woodbank and ditch which is likely to have historic origins and may originally have been used to manage unwanted livestock access into or from the woodland to the surrounding areas.
