# Appendix 12A: Ground Investigation Report

# SEMMMS, A6 to Manchester Airport, Relief Road, Ground Investigation Report

#### SEMMMS, A6 to Manchester Airport, Relief Road

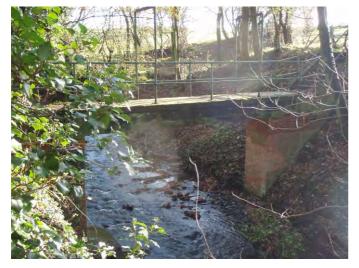
Photograph 9 – Norbury Brook footbridge at Old Mill Lane

- Old Mill Lane reduces in level from Mill Lane to the proposed road alignment and where Norbury Brook is located (Photograph 7).
- A retaining wall that is possibly associated with the former mill buildings is visible (Photograph 8).
- A footbridge crosses Norbury Brook (Photograph 9).
- The land on the proposed road alignment either side of Macclesfield Road is grassed fields (Photograph 10 and 11).
- A slope / ridge crosses the field to the west of Macclesfield Road. The ridge appears to be approximately 3m high (Photograph 10).
- Brookside Garden Centre car park is present to the south of the alignment east of Macclesfield Road.
- Ground levels reduce significantly from Mill Hill Hollow (road). The reduction in ground level appears to be associated with the valley of Norbury Brook. Ground level reduces towards Norbury Brook in a north-easterly direction (Photograph 12).

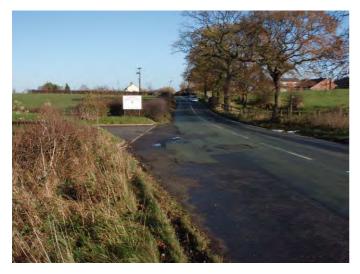
Photograph 14 – View looking north at the proposed Woodford Road crossing.

- Land along the proposed road alignment is grassed fields used by livestock (Photograph 13).
- Land rises to the north at the proposed Woodford Road crossing (Photograph 14).
- The west coast mainline passes under Woodford Road in an approximately 4m deep cutting. The cutting reduces in depth towards the proposed road alignment (Photograph 15).

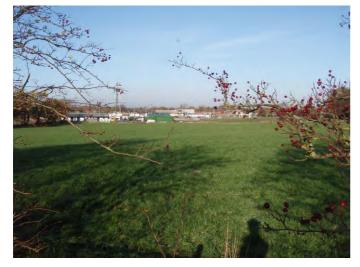
Photograph 17 – Possible fuel storage depot.

- The land along the proposed road alignment is farm fields in the east of the area (Photograph 16) and a golf course in the west. The land is slightly hummocky in this area.
- A depot that appears to be a fuel storage depot is located to the north of the proposed alignment (Photograph 17). The road to the depot from Chester Road has a concrete surface.
- A pond is present on the proposed alignment within the golf course (Photograph 18). The majority of the golf course was not accessible.
- The land surrounding Chester Road is generally flat. Houses are present on the southeast side of the road (Photograph 19).

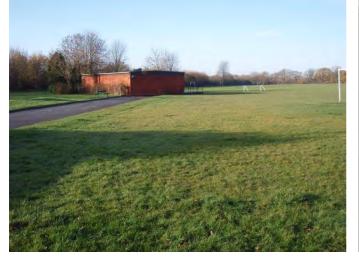
Photograph 21 – Woodford Recreation Ground and pavilion - looking west.

- The existing A555 joins Woodford Road at a roundabout. The A555 reduces in level to the west from Woodford Road (Photograph 20).
- Woodford recreation ground is located on the northern side of the A555 immediately west of the existing junction with Woodford Road. The recreation ground comprises flat fields with access roads and a sports pavilion. The sports pavilion is a single storey building (Photograph 21).

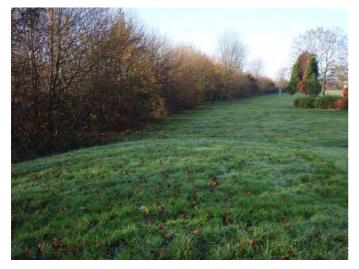
Photograph 22 – Crest of A555 northern cutting slope at Woodford Recreation Ground – Looking west.

- A small bund is present in the recreational ground to the east of the sports pavilion. The bund is approximately 1m high (Photograph 22).
- The crest of the existing A555 cutting is populated with trees (Photograph 22).

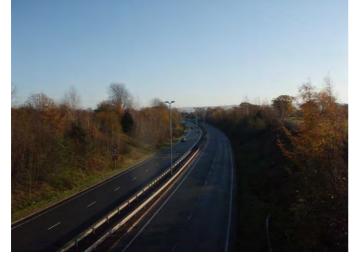
Photograph 25 – Woodford Road junction viewed from footbridge – looking east.

- A footbridge crosses over the A555 at top of cutting level, approximately 500m east of the junction with Woodford Road.
- Woodford Road is in cutting between the footbridge and Woodford Road. The cutting reduces in depth from the footbridge from approximately 10m deep to at grade at Woodford Road. The cutting slopes are vegetated with trees and bushes (Photograph 25).

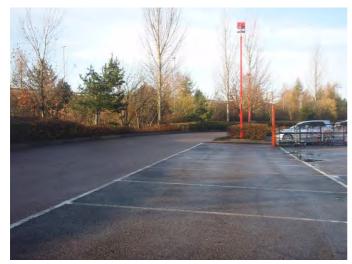
Photograph 26 – Stanley green retail park, looking south towards A555.

- Stanley Green Retail Park is located on the north side of the existing A555, north of the east bound exit slip road to the junction with the A34.
- The existing A555 is on an approximately 6m high embankment at the site (Photograph 26).

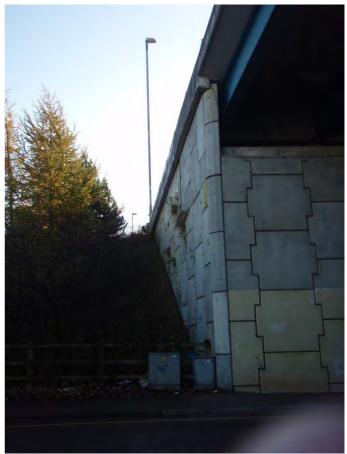
Photograph 27 – Earl Road Bridge eastern abutment and north-eastern wing wall.

- The A555 is carried over Earl Road on a bridge which appears to have reinforced earth abutments and wing walls (Photograph 27).

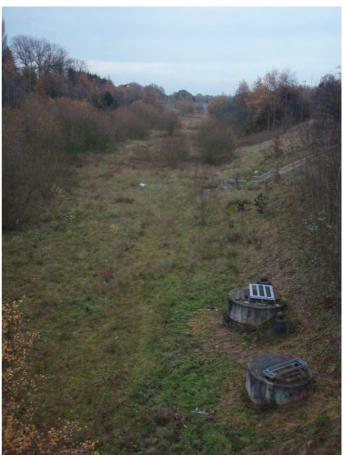
Photograph 29 – A555 looking east from Wilmslow Road bridge.

- The existing A555 junction with Wilmslow Road comprises the eastbound entry slip road and the west bound exit slip road. Both roads terminate at separate roundabouts which are connected by a road carried by a bridge. This bridge spans an unfinished section of the A555 which ends in a cutting slope on the east side of the bridge (Photograph 28). Raised manholes are visible in the unfinished section of road to the east of Wilmslow Road (Photograph 29).

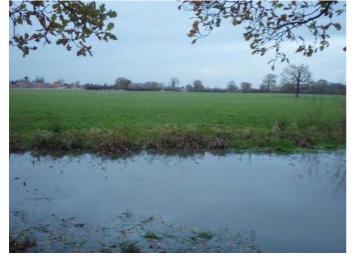
Photograph 30 – Grassed fields with pond. Looking east from the site of the proposed footbridge

- The land along this section is predominantly fields that are grassed or rough grass land (Photograph 30 and 31 respectively). Ponds are present within the fields on and adjacent to the alignment, including one immediately east of the proposed footbridge (Photograph 30).

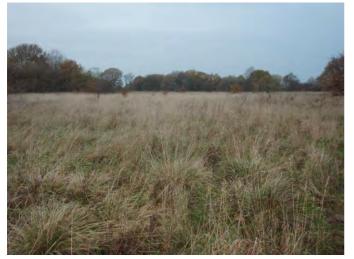
Photograph 31 – Rough grass land – Looking west from site of proposed footbridge.

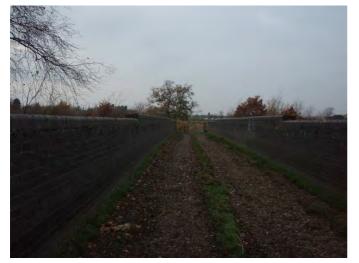
Photograph 34 - Rail bridge - looking west

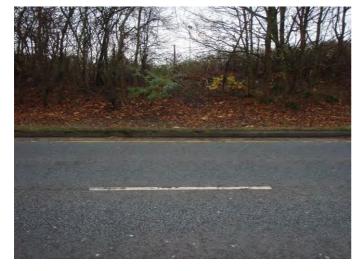
Photograph 42 - Ringway Road West cutting - looking south.

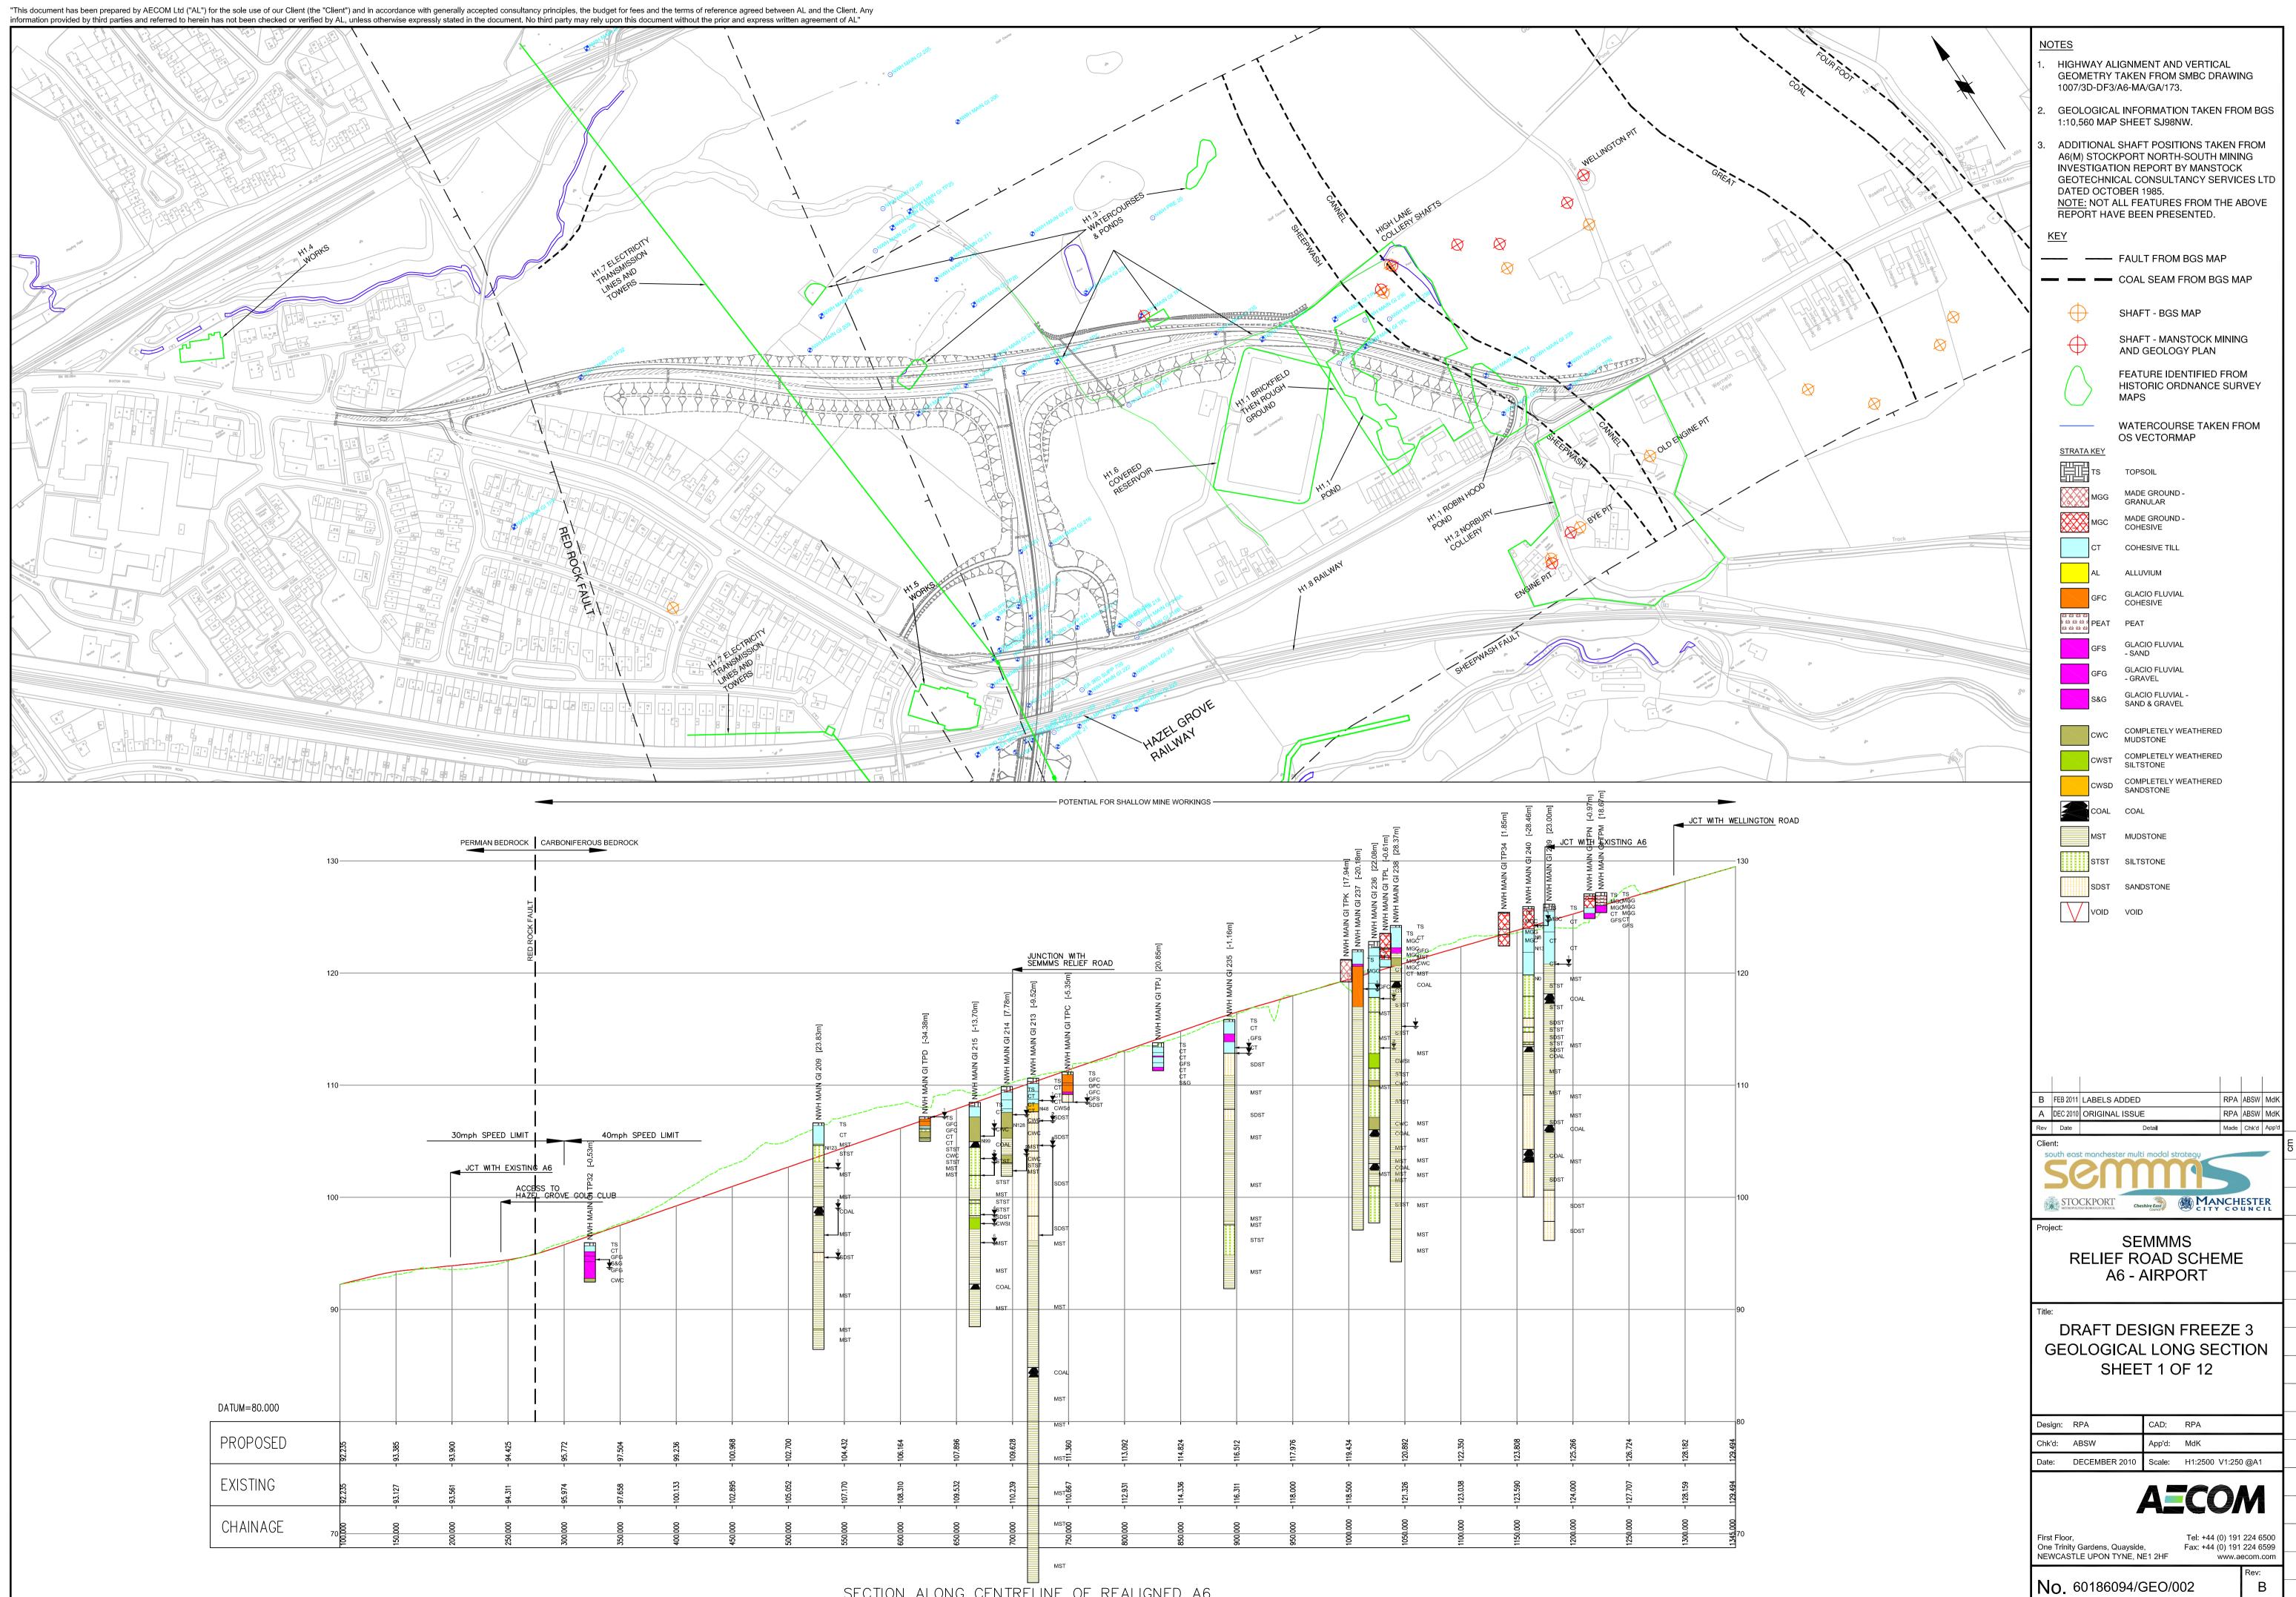
SECTION ALONG CENTRELINE OF REALIGNED A6

## **GEOLOGICAL LONG SECTION** KEY PLAN AND GROUND INVESTIGATION REFERENCE LIST

_		FAULT FROM BGS MAP
		COAL SEAM FROM BGS MAP
)		SHAFT - BGS MAP
		SHAFT - MANSTOCK MINING AND GEOLOGY PLAN
	>	FEATURE IDENTIFIED FROM HISTORIC ORDNANCE SURVEY MAPS
	_	WATERCOURSE TAKEN FROM OS VECTORMAP
TA	KEY	
	TS	TOPSOIL
X	MGG	MADE GROUND - GRANULAR
X	MGC	MADE GROUND - COHESIVE
	СТ	COHESIVE TILL
	AL	ALLUVIUM
	GFC	GLACIO FLUVIAL COHESIVE
к лл лл л лл л лл л	PEAT	PEAT
	GFS	GLACIO FLUVIAL - SAND
/	GFG	GLACIO FLUVIAL - GRAVEL
	S&G	GLACIO FLUVIAL - SAND & GRAVEL
/	CWC	COMPLETELY WEATHERED MUDSTONE
	CWST	COMPLETELY WEATHERED SILTSTONE
	CWSD	COMPLETELY WEATHERED SANDSTONE
	COAL	COAL
	MST	MUDSTONE
	STST	SILTSTONE
	SDST	SANDSTONE
/	VOID	VOID

The ground conditions encountered during the ground investigations are shown on Drawings 60186094/GEO/002 and 60186094/GEO/003. The geology comprises firm to stiff glacial till overlying the mudstone, siltstone and sandstone of the Westphalian Coal Measures. Cohesive made ground was encountered between CH1000 and CH1200.

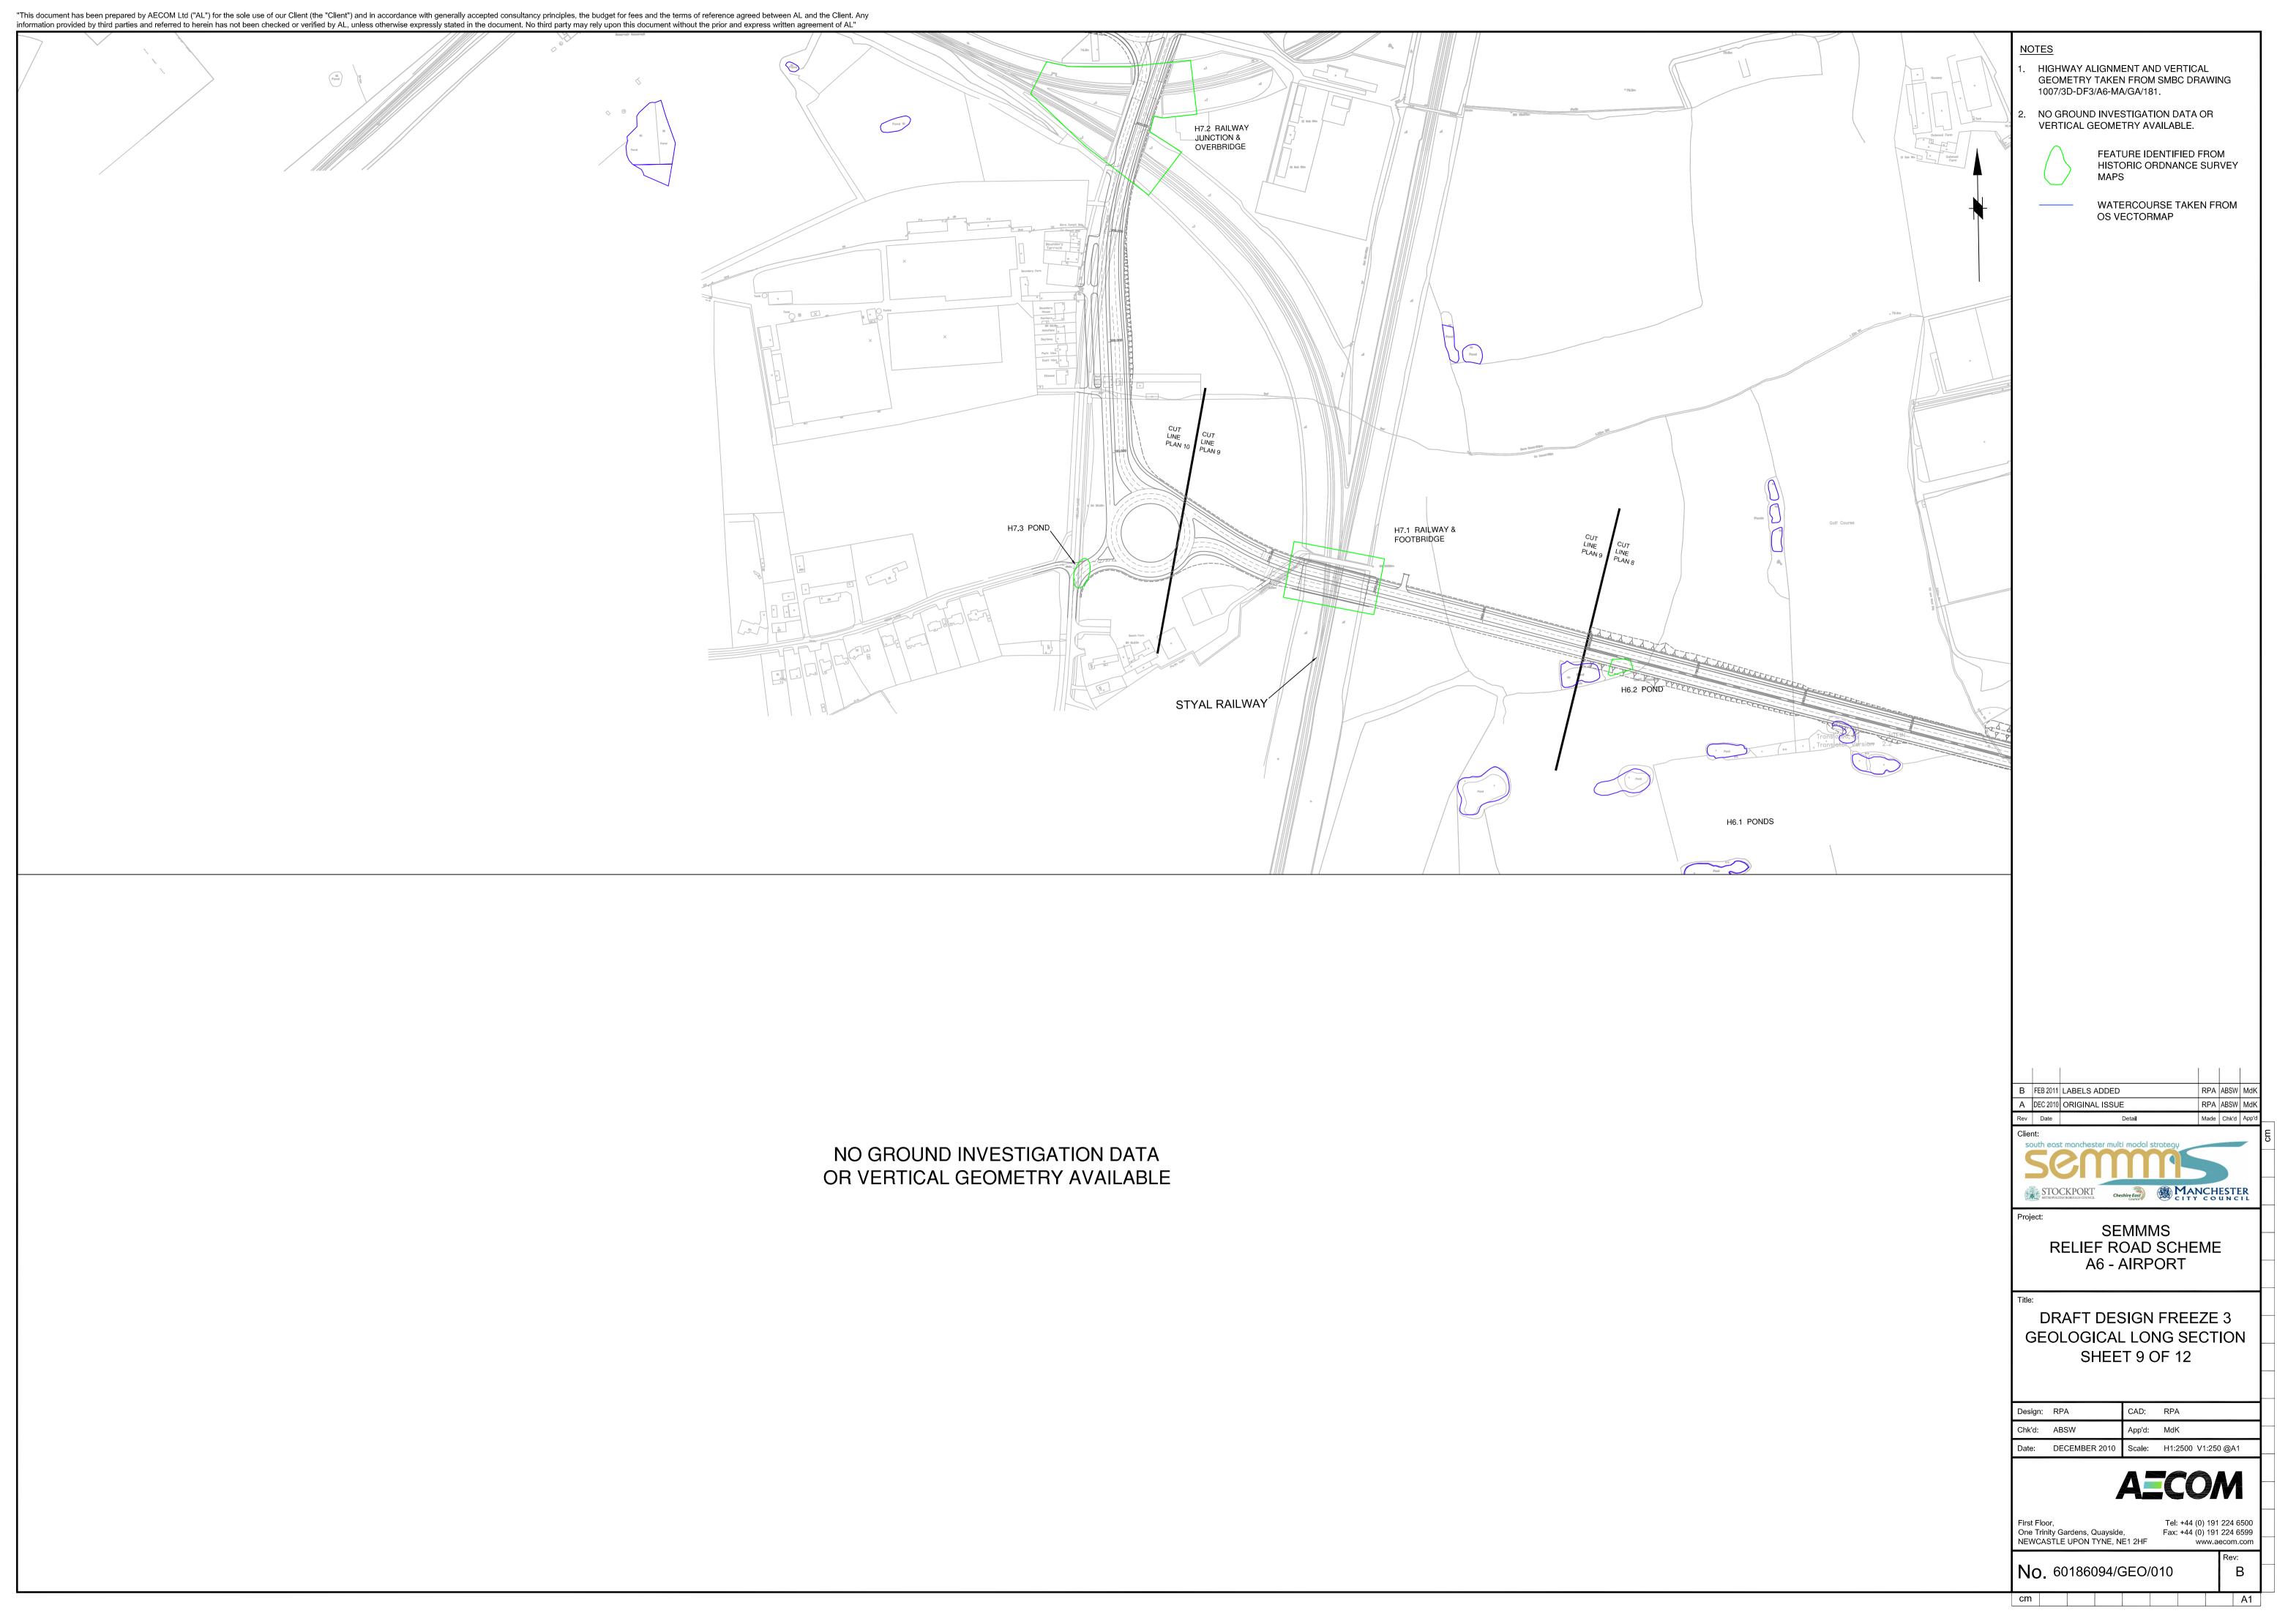
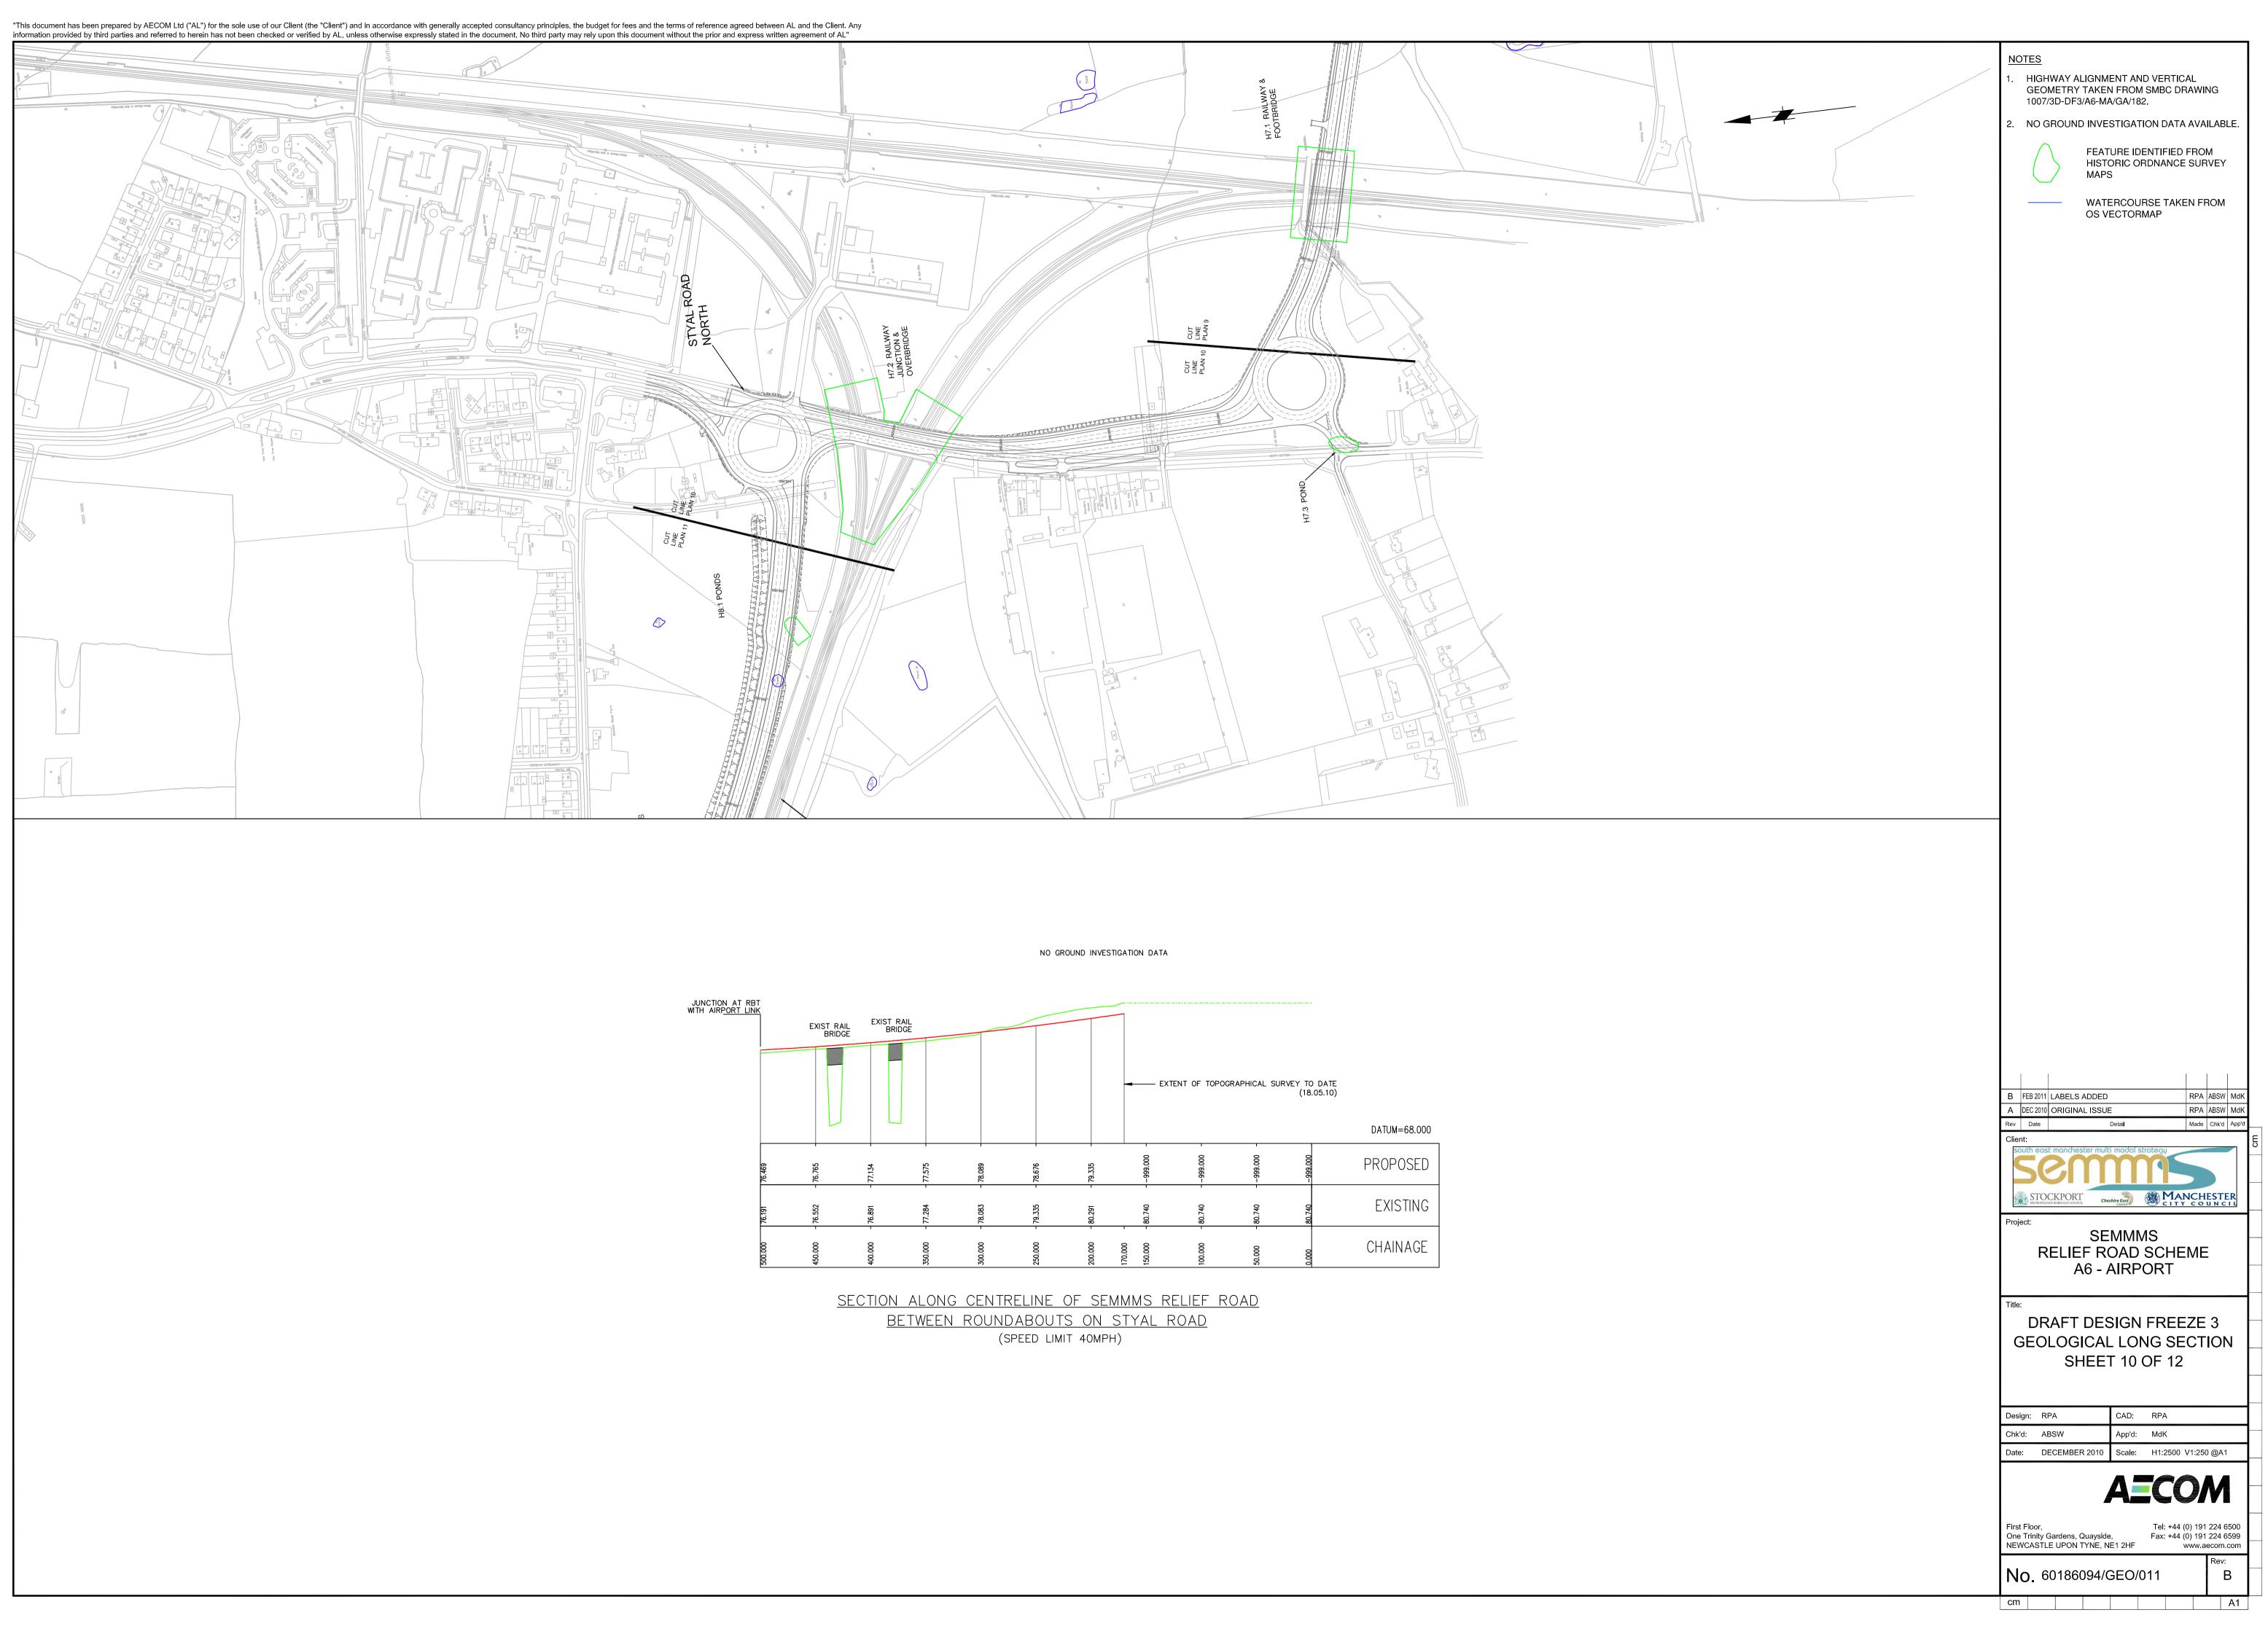
AIL )GE	EXIST RAIL BRIDGE									
						EXTENT	OF TOPOGRAF		( TO DATE (18.05.10)	
J										DATUM=68.000
171 LL			600.00 0	/8.0/0 79.335 -		- 000.666 -	- 000.666-	- 000.666 -	- 999.000	PROPOSED
100 JL	- 10.031 1. 1. 1. 1. 1. 1. 1. 1. 1. 1. 1. 1. 1. 1	107.17		- 192.08		80.740 -	80.740	80.740 -	80.740	EXISTING
				- 000.002	170.000 -	150.000 -	100.000	50.000	0.000	CHAINAGE

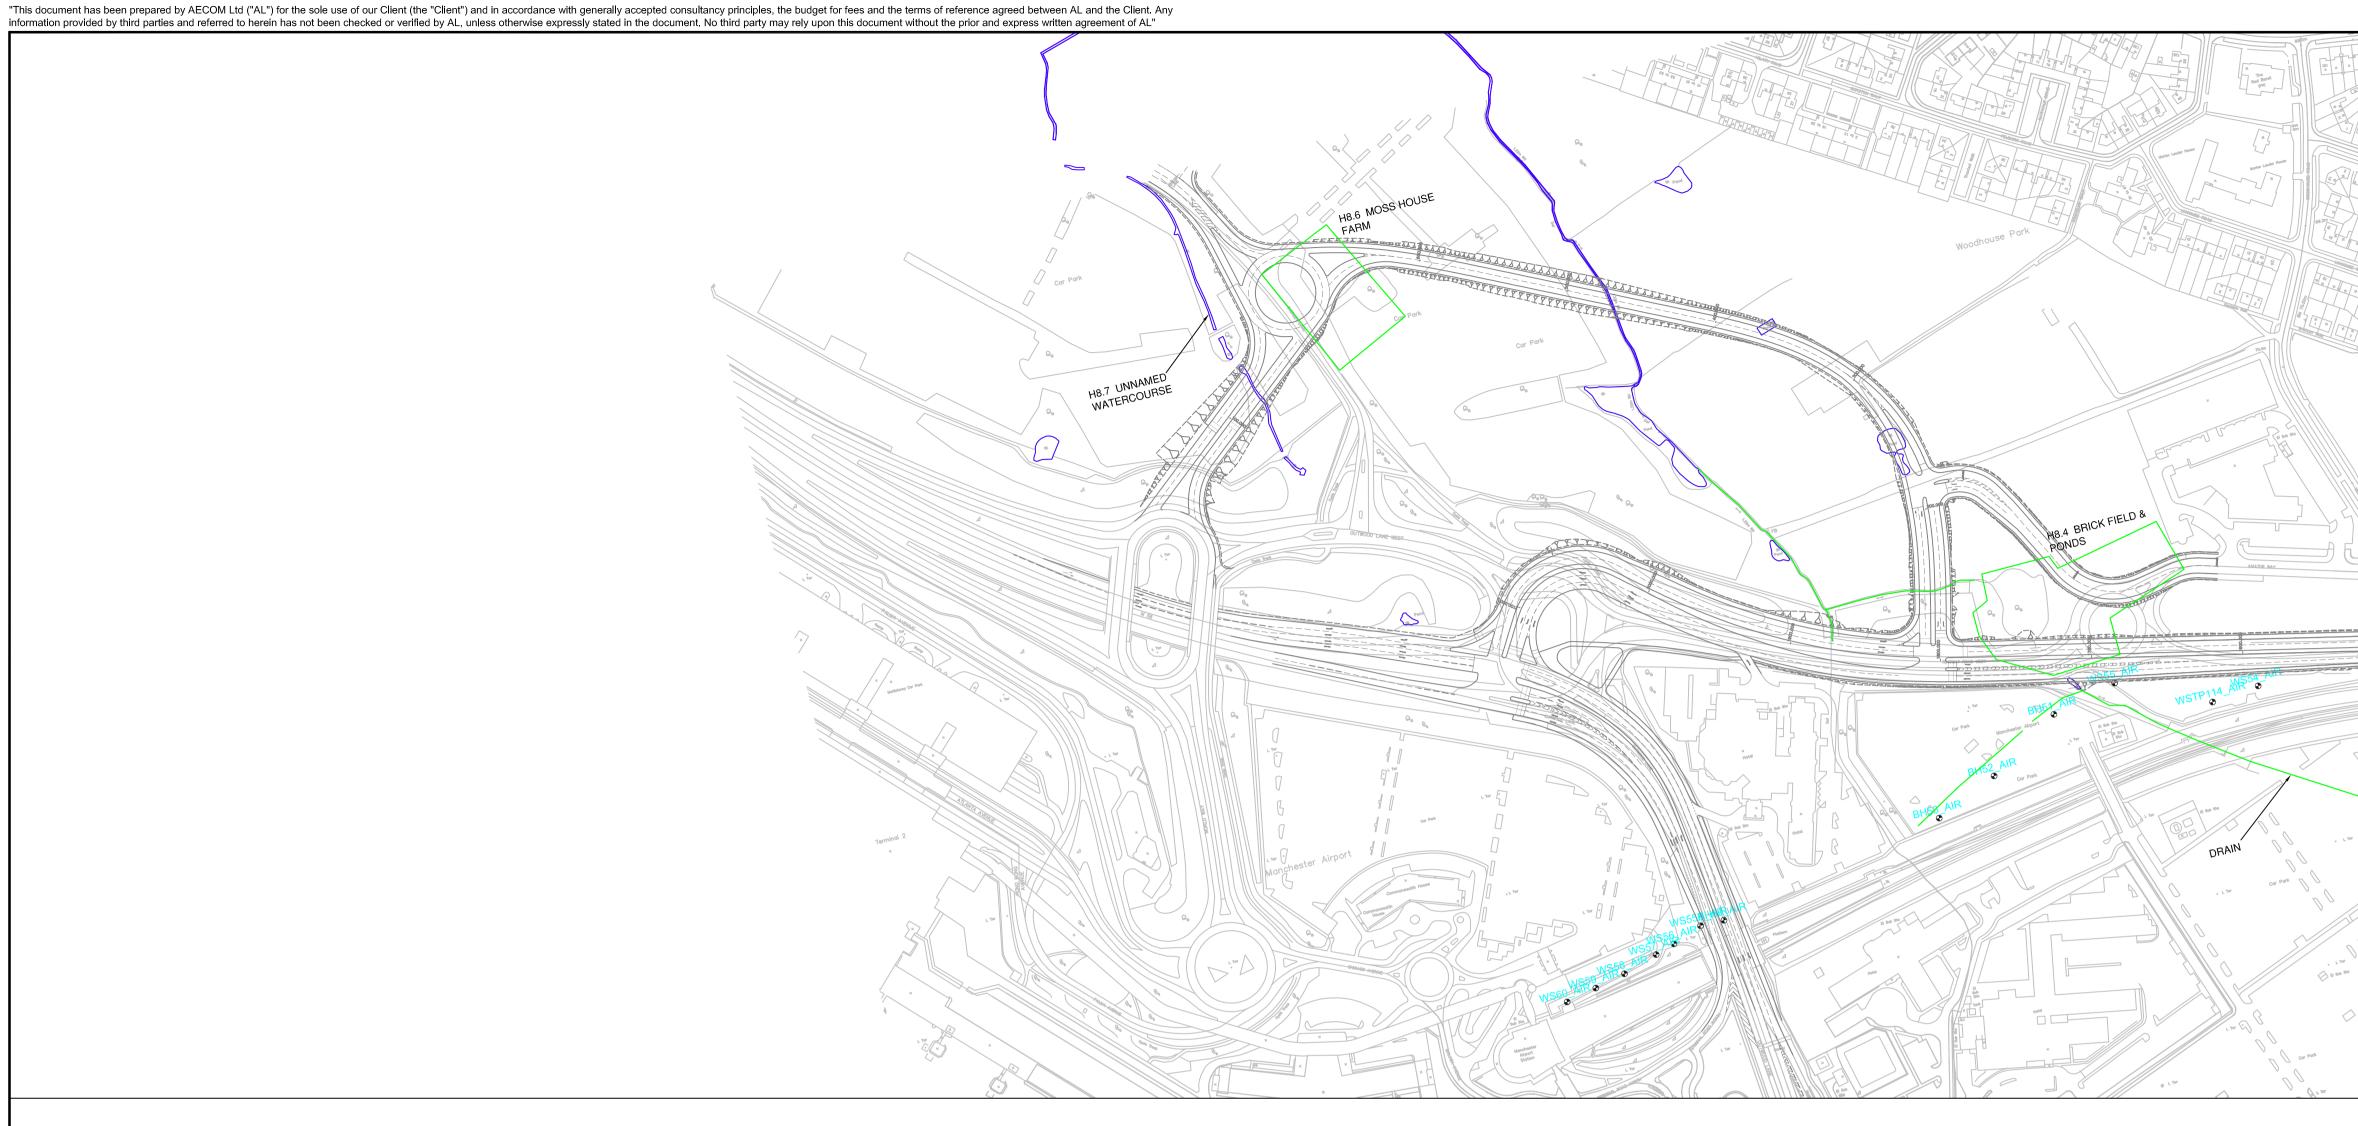
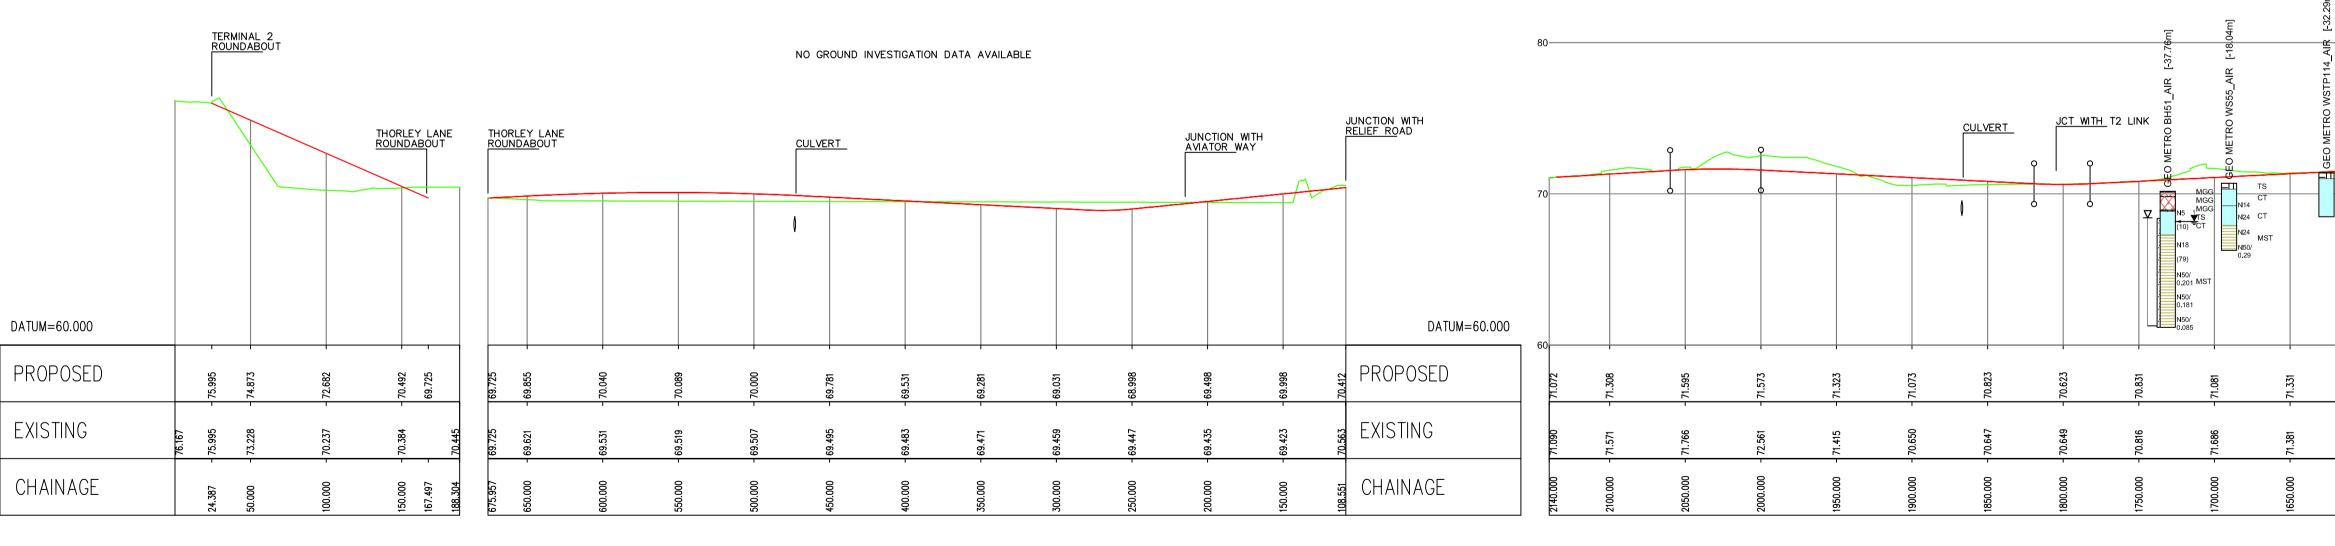
SECTION ALONG CENTRELINE OF TERMINAL 2 LINK ROAD (SPEED LIMIT 30MPH)

SECTION ALONG CENTRELINE OF SEMMMS RELIEF ROAD STYAL ROAD TO MANCHESTER INTERNATIONAL AIRPORT (SPEED LIMIT 40MPH)

No ground investigation data is available for the Terminal 2 link road, however it is anticipated that the ground conditions will comprise glacial till over mudstone at around 5m depth. Localised alluvial deposits are expected, associated with the small streams in this area.
